# Manhole Inspection Summary

Manhole # S09SS\_010MH

**Location** Address: **POWHATAN AVE**

Cross Street: **HILTON ST**

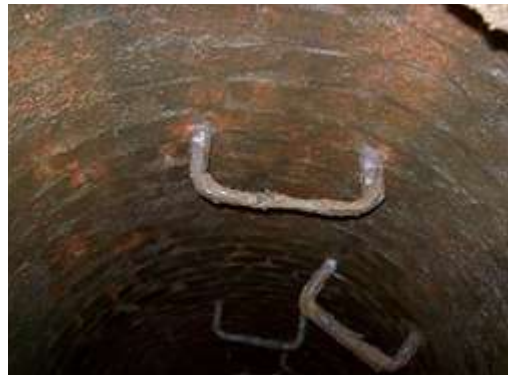
Defect 1

Count: **8** Missing: **0** ☒ **Corroded**

CORRODED STEPS

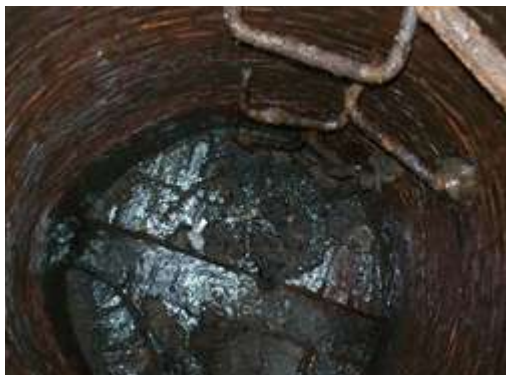
Defect 3

Condition: ☐ Sound ☐ Cracked ☐ Root Intrusion ☐ Deteriorated ☐ Leaks ☒ **Debris**

☒ **Evidence Of Surcharge** Depth: **1** (ft.) ☐ Active Surcharge Present

DEBRIS ON BENCH; EVIDENCE SURCHARGE

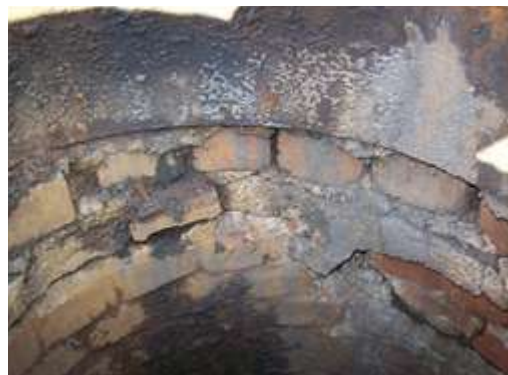
Defect 2

Condition: ☐ Sound ☐ Cracked ☐ Root Intrusion ☒ **Loose Brick** ☒ **Deteriorated**

DETERIATED CHIMNEY

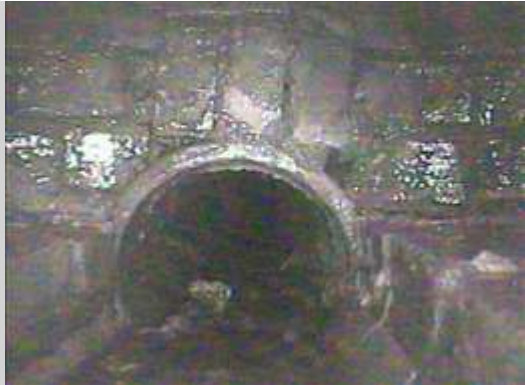
12 O'Clock Outflow

Infiltration: **None** Pipe Seal Cond: **Cracked**

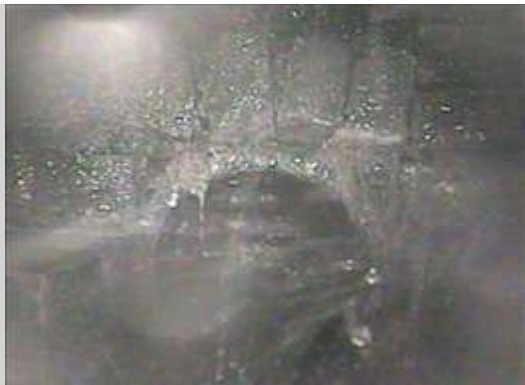
6 O'Clock Inflow

Infiltration: **None** Pipe Seal Cond: **Cracked**

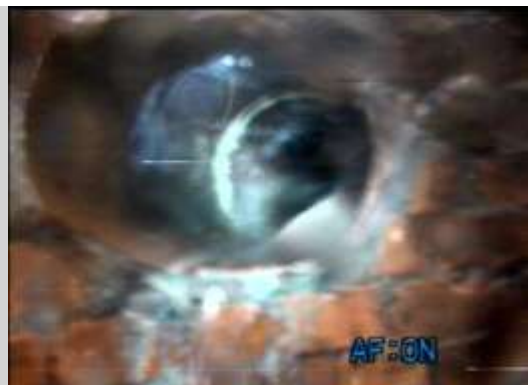
Pipe In @ 9 O'Clock

CLOGGED

Deposits: ☐ None ☐ Mud ☒ **Sludge** ☒ **Debris** ☒ **Grease**

Silt Depth: **8** (in.) Deposits Extent: **Heavy**

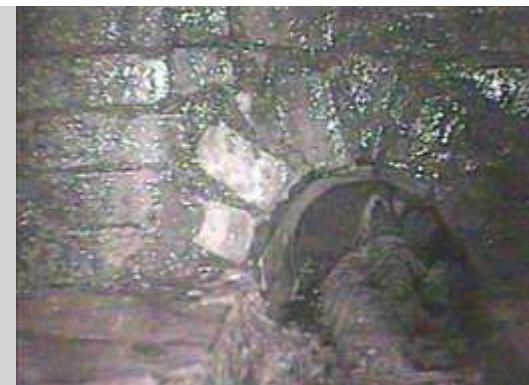
Drop In @ 9 O'Clock

CLOGGED

Drop Condition: **Clogged**
